# **FUL-02-2.858**

## **Safety Study**

**Stryker Street/SR-2 at Frey Road/TR-24**  
**Village of Archbold**  
**2021 HSIP Intersection Rank #233**

March 27, 2024

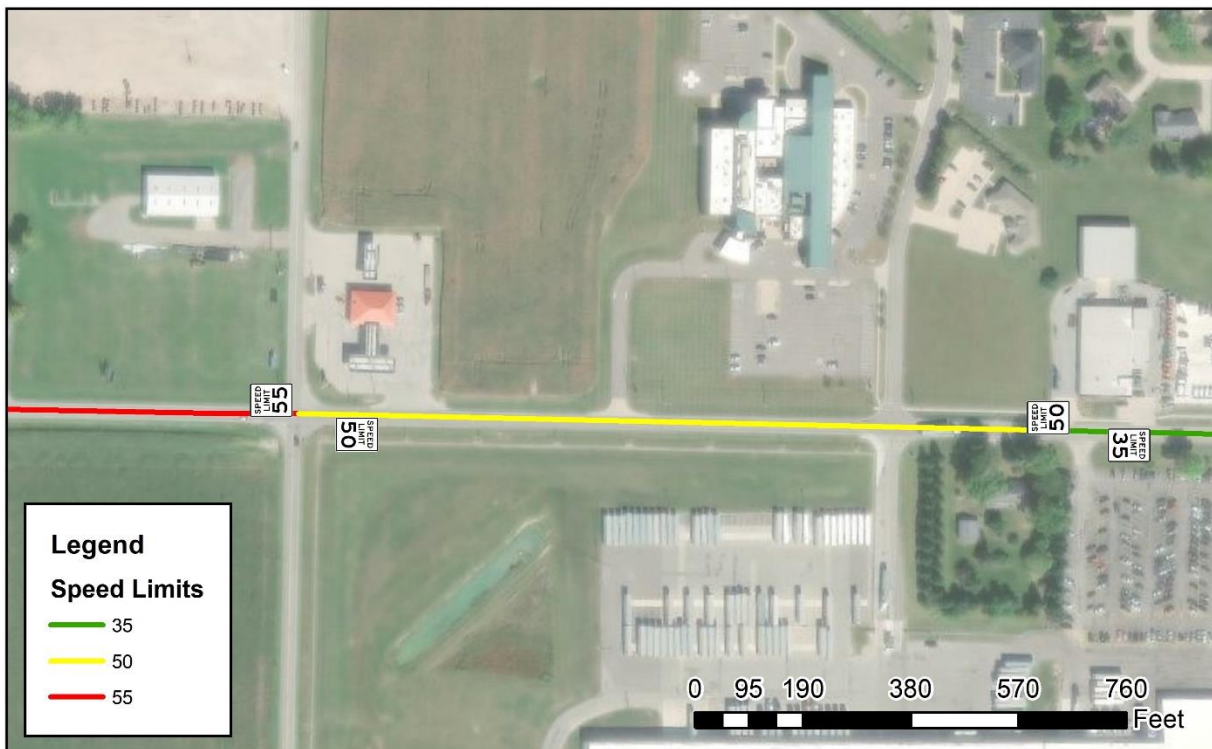
Figure 1 Stryker Street/SR-2 Speed Limits

The speed limits on Stryker Street/SR-2 and their spacing were also evaluated to determine if vehicles speeds were contributing to crashes at the intersection being studied. Stryker Street/SR-2 west of the intersection is 55 MPH until it goes through the Village of Stryker approximately 5 miles away. Traffic traveling eastbound through the intersection with Frey Road/TR-24 has their speed drop from 55 MPH to 50 MPH immediately after the intersection and then drops again to 35 MPH about 1,460 feet east of Frey Road/TR-24. Similarly, traffic traveling westbound on Stryker Street/SR-2 has their speed limit rise from 35 MPH to 50 MPH about 1,300 feet east of the intersection and then rises again to 55 MPH at the intersection with Frey Road/TR-24. The speed limits and their spacing can be seen in Figure 1.

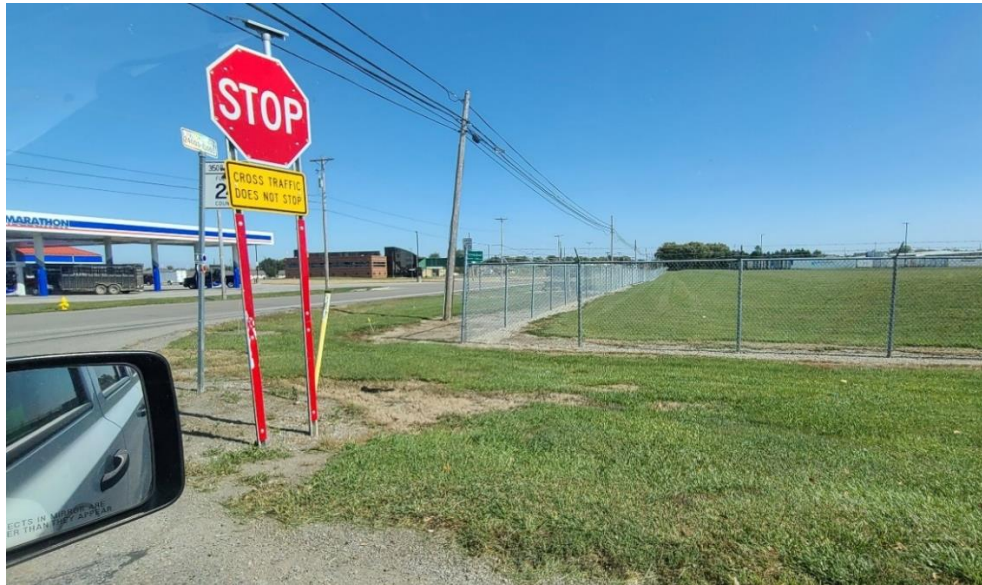
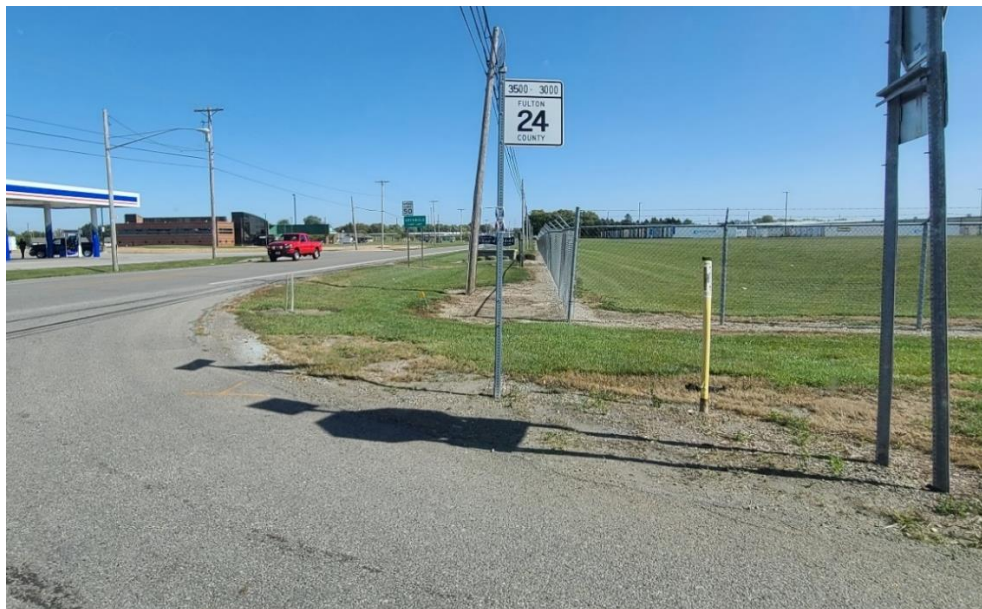
Sight distances were evaluated for the stop-controlled approaches of Frey Road/TR-24 at Stryker Street/SR-2 and found obstructions that could make it difficult for drivers to determine adequate gaps to proceed through the intersection. Most notably, vehicles entering the intersection on the south leg of Frey Road/TR-24 have a lot of visual clutter when looking east. Figure 5 and Figure 6 show these limited sight distances at the stop sign on the south leg as well as in front of the stop sign as many vehicles were observed creeping further into the intersection for better sight distances. The fence and the village welcome sign seem to be the obstructions contributing most to the sight distance issues along the southeastern quadrant of the intersection. The sight distance looking west did not have significant sight obstructions during the site visit but could be an issue if the farm field on the southwest corner of the intersection was growing tall crops such as corn.

**Figure 5** Northbound looking east at the stop sign

**Figure 6** Northbound looking east, past the stop sign

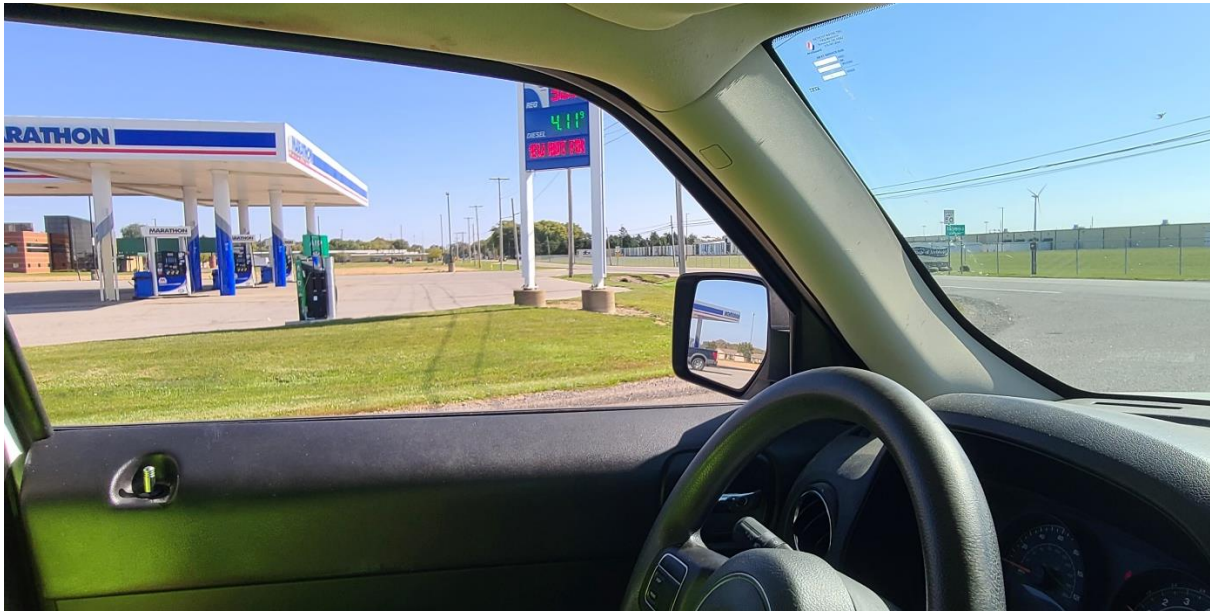
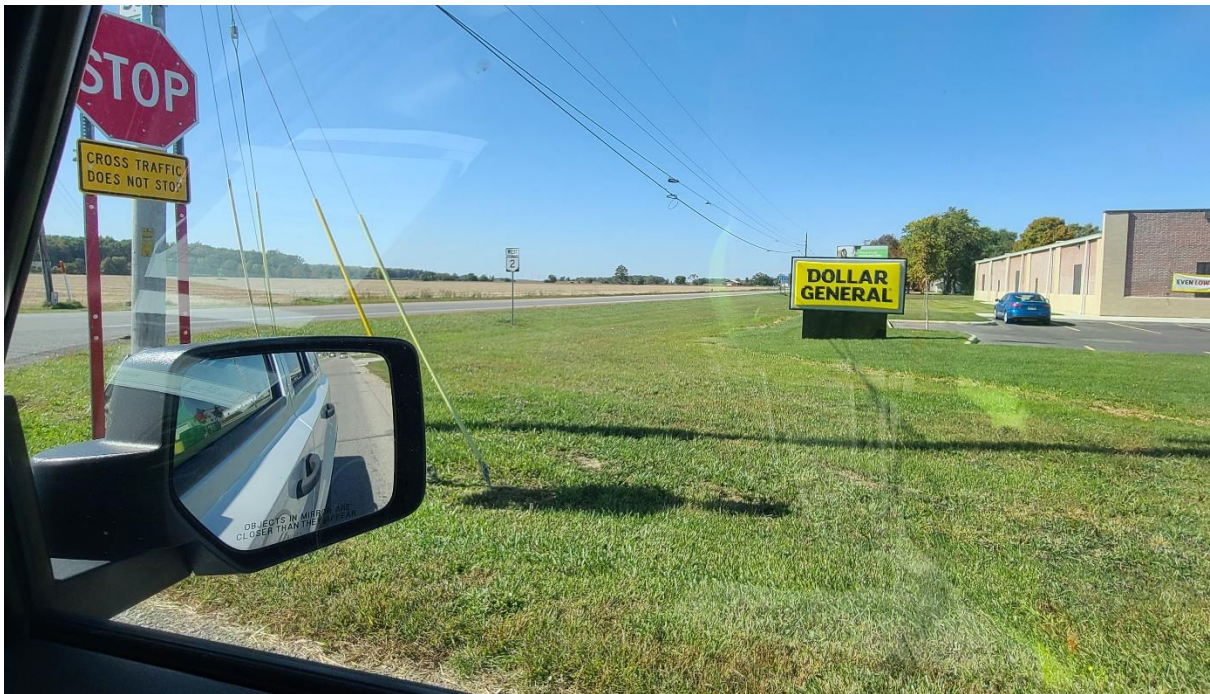
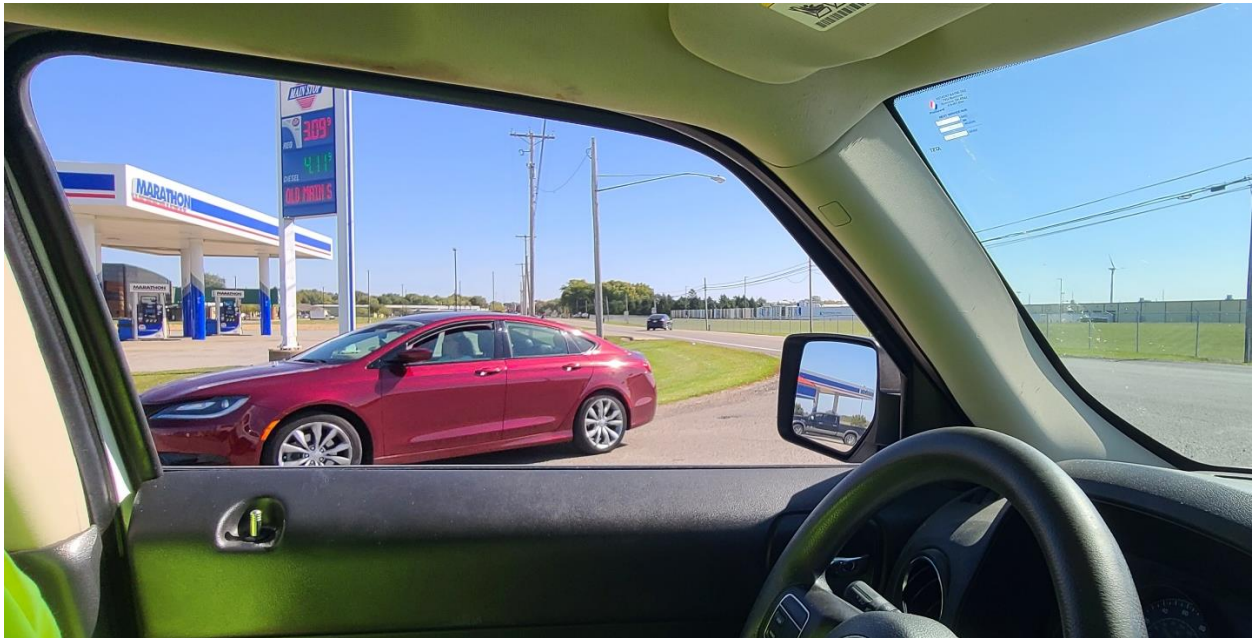
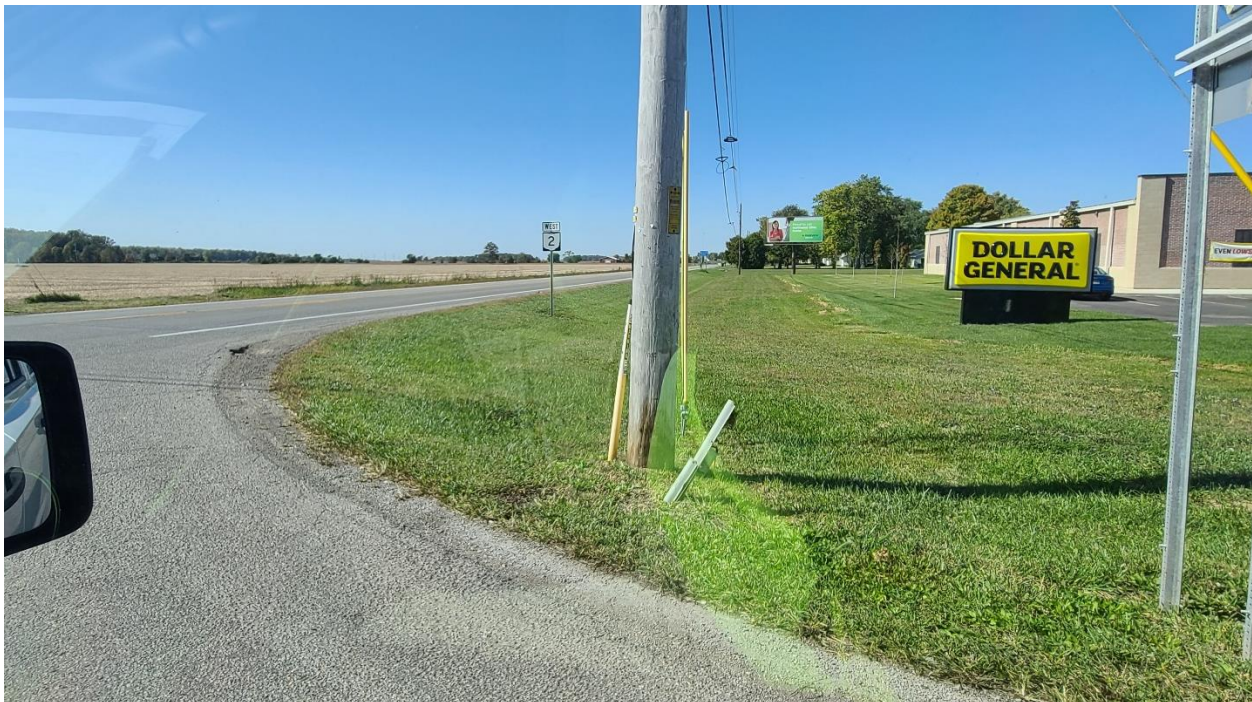
The north leg also has sight obstructions to the east and west due to commercial signage as well as utility poles that create a screen to make the judgement of gaps in traffic more difficult. The access point on Stryker Street/SR-2 for the Marathon gas station on the northeast corner of the intersection can also create sight obstructions if there are vehicles waiting to exit onto Stryker Street/SR-2. Figures 7 through Figure 10 show the varying sight obstructions for stopped southbound traffic.

**Figure 7** Southbound looking east, at the stop sign

**Figure 8** Southbound looking west, at the stop sign

**Figure 9** Southbound looking east, past the stop sign

**Figure 10** Southbound looking west, past the stop sign
